To Soda Blast or Not?

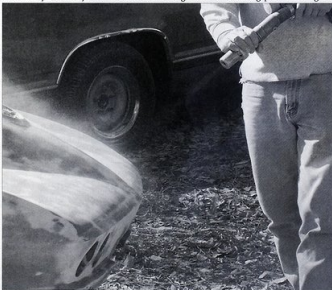
Here's how I set the car up for the blasting process. The doors, hood and back valance were removed from the car. While the doors were off to facilitate replacing the hinge pins, it did allow the blaster easy access to the jamb. As you can see, I taped over the openings. It wasn't enough. See the text for more information.

I parked the car in an open area in the rear of my property. As I began to prepare the car for the process I attempted to minimize the access of the soda to the engine compartment, the dash area and the interior generally. I had removed the doors to re-bush the hinges and the blaster suggested I leave them off. Using duct tape instead of masking tape to get good adhesion, I taped 6-mil plastic over and under the dash. I taped the hood ledges, which I had chemically stripped, and down the front to the underside of the car. I masked the door openings with the plastic and I thought I had eliminated the prospect of soda getting everywhere.
